PERCUTANEOUS SPINAL TRAUMA TREATMENT USING THE VIPER2 SYSTEM

Tony Tannoury, MD
Boston University, Department of Orthopaedics

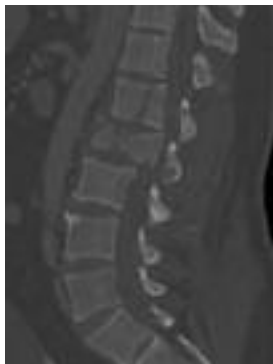
Figure 1: Lateral CT Scan

- A 48-year old male construction worker arrived at the ER after falling from a three story building
- The patient was neurologically intact but demonstrated signs of bilateral leg weakness
- Imaging revealed L1 and L2 burst fractures with a severely compromised canal at both levels (Figures 1, 2, & 3)

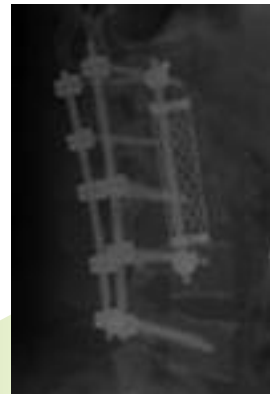
Figure 4: Post-op Lateral Radiograph

- An anterior corpectomy was performed at L1/ L2 and an 80mm mesh cage was inserted into the space left from T12 to L3
- A unilateral anterior EXPEDIUM rod and screw construct was inserted laterally from T12 to L3 to support the anterior column
- Nine percutaneous VIPER screws were placed bi-laterally at every level from T12 to L4 except in the left pedicle on L1
- Bilateral 120mm VIPER 2 rods were placed percutaneously starting from T12 (Figures 4 & 5) to L4
- OR time for the posterior portion of the case was approximately 75 minutes with 75cc of blood loss and no complications

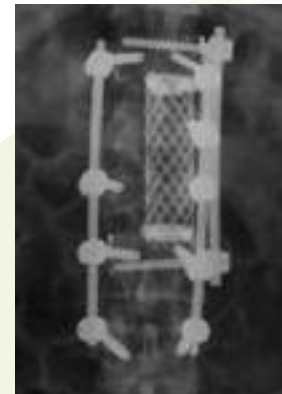
Figure 5: Post-op A-P Radiograph
